TECHNICAL REPORT CERC-85-8

BREAKWATER REHABILITATION STUDY, CRESCENT CITY HARBOR, CALIFORNIA

Coastal Model Investigation

Coastal Engineering Research Center

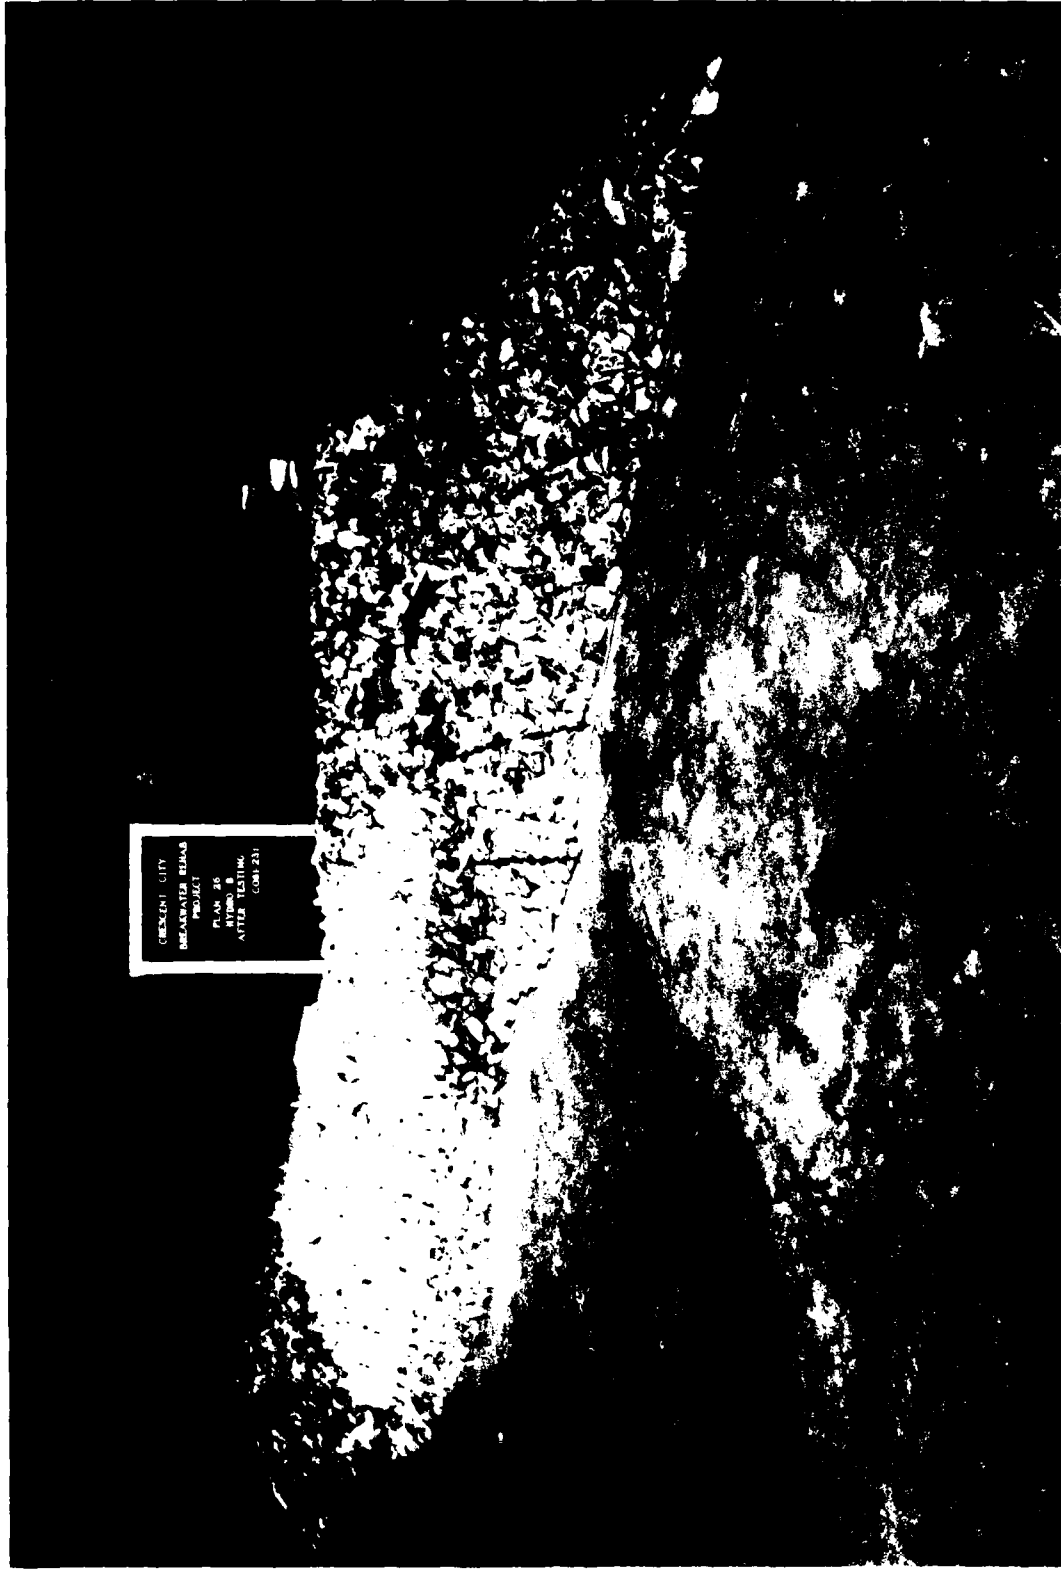
Photo 205. Sea-side view of Plan 26 after cumulative testing of Hydrographs A and B

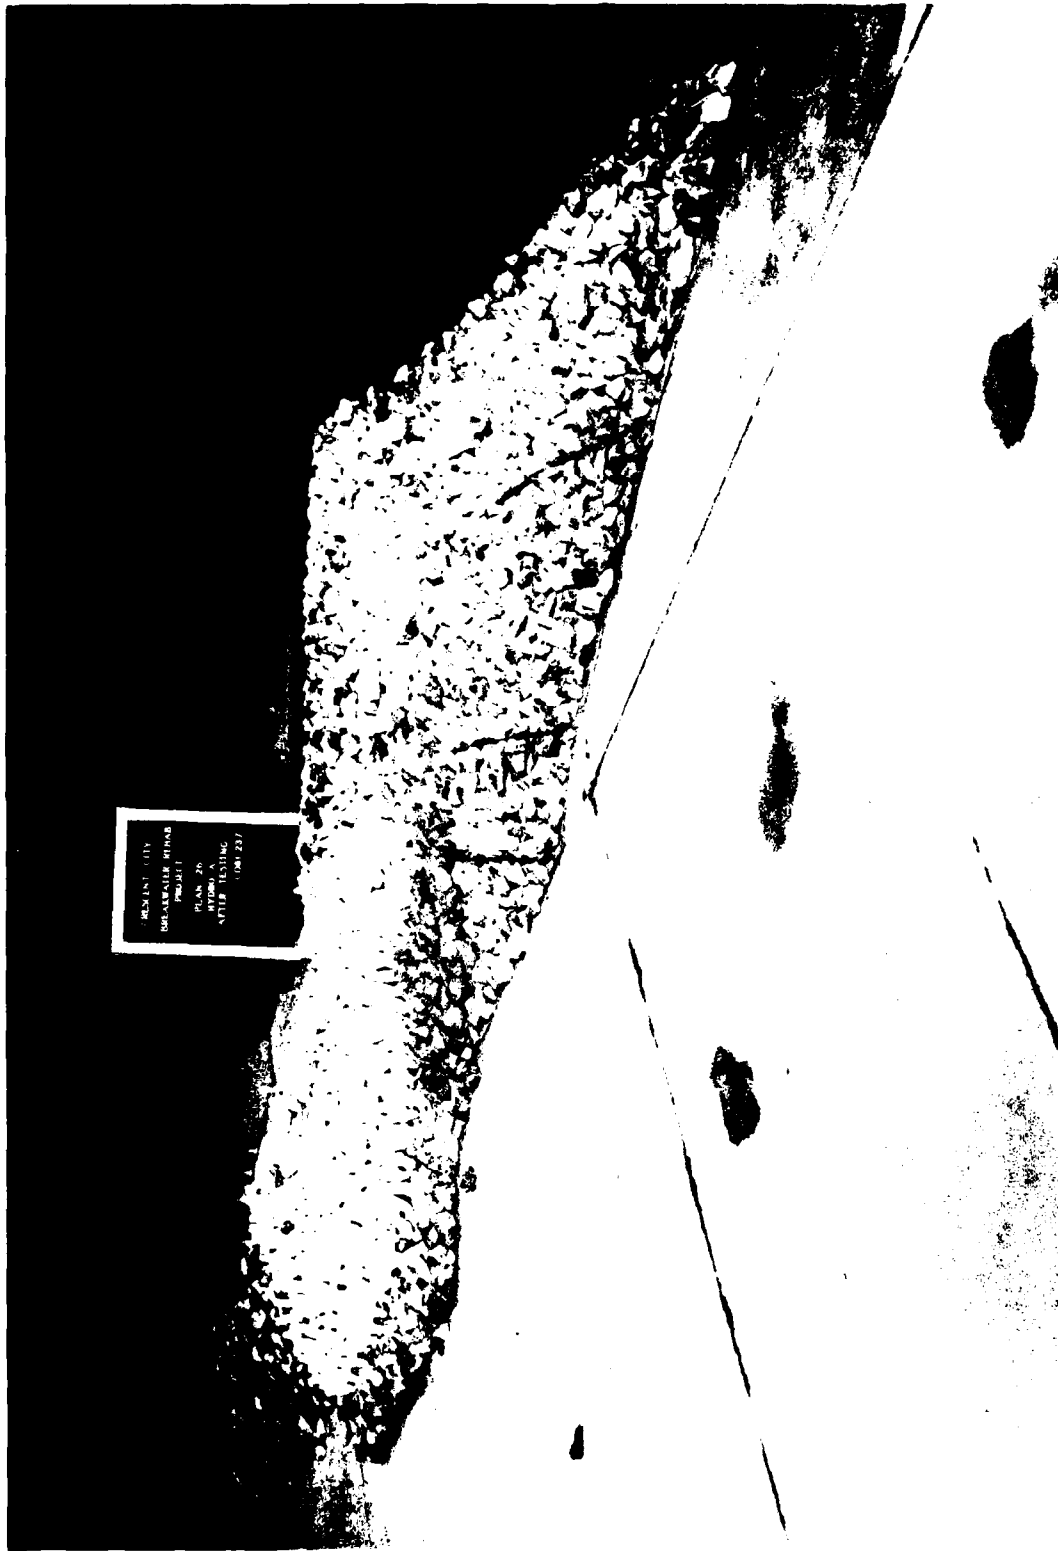
Photo 211. Sea-side view of Plan 26 after second repeat test with Hydrograph A

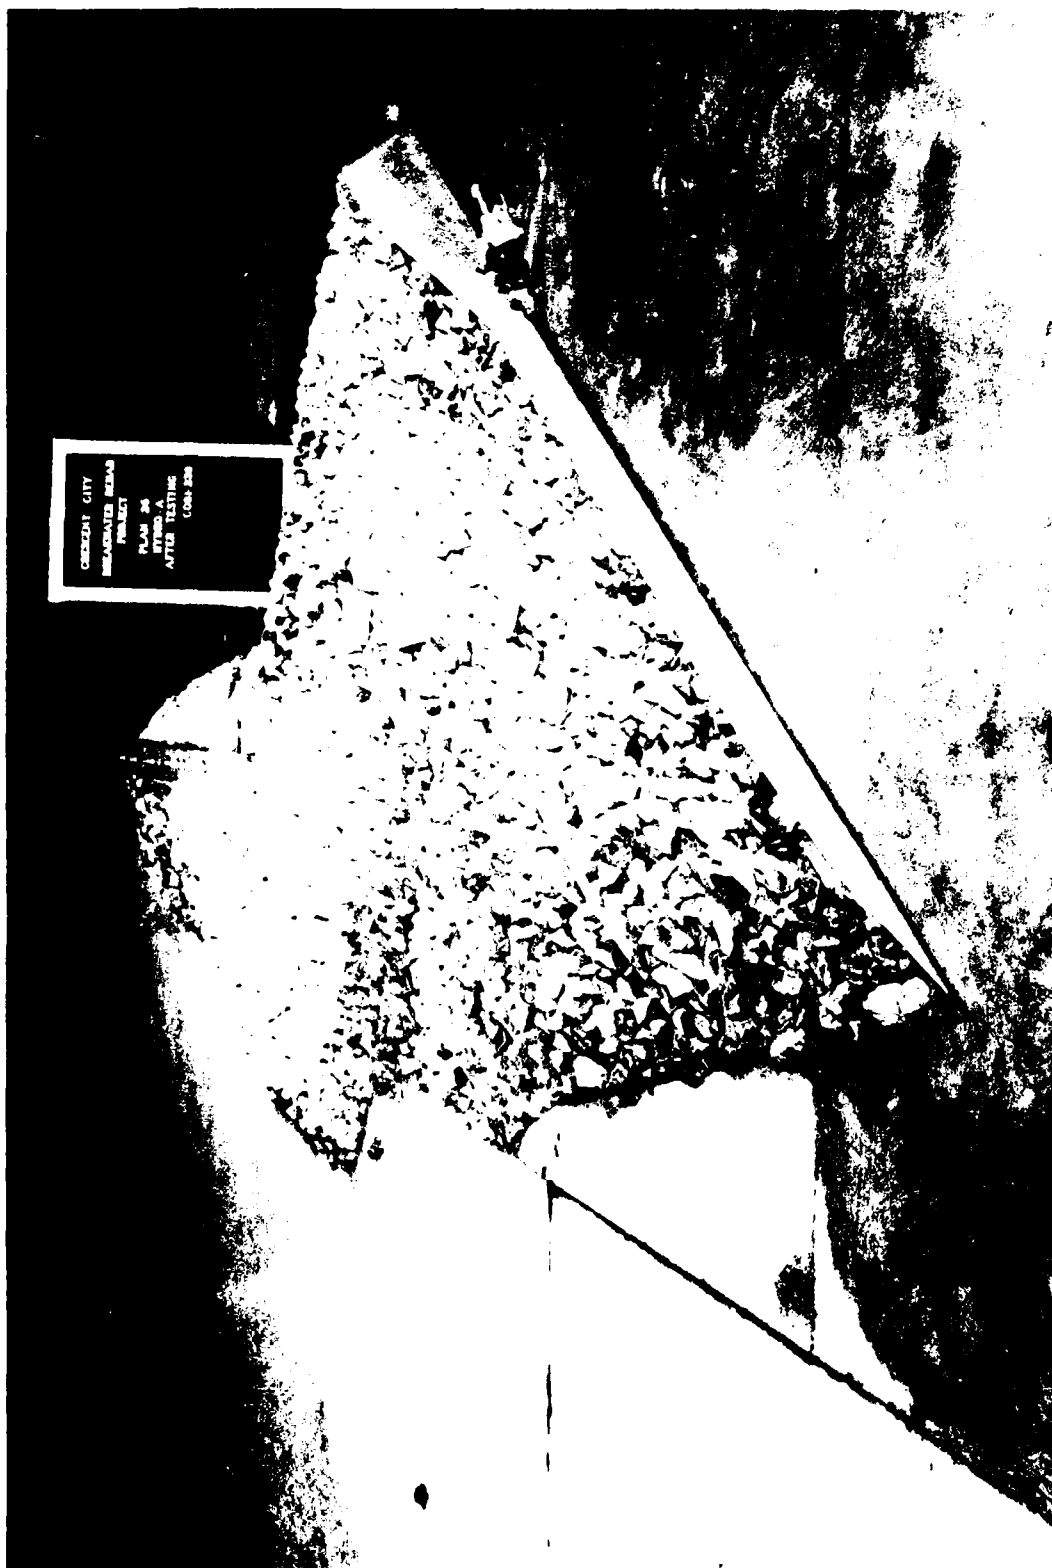
Photo 212. Seaward oblique view of Plan 26 after second repeat test with Hydrograph A

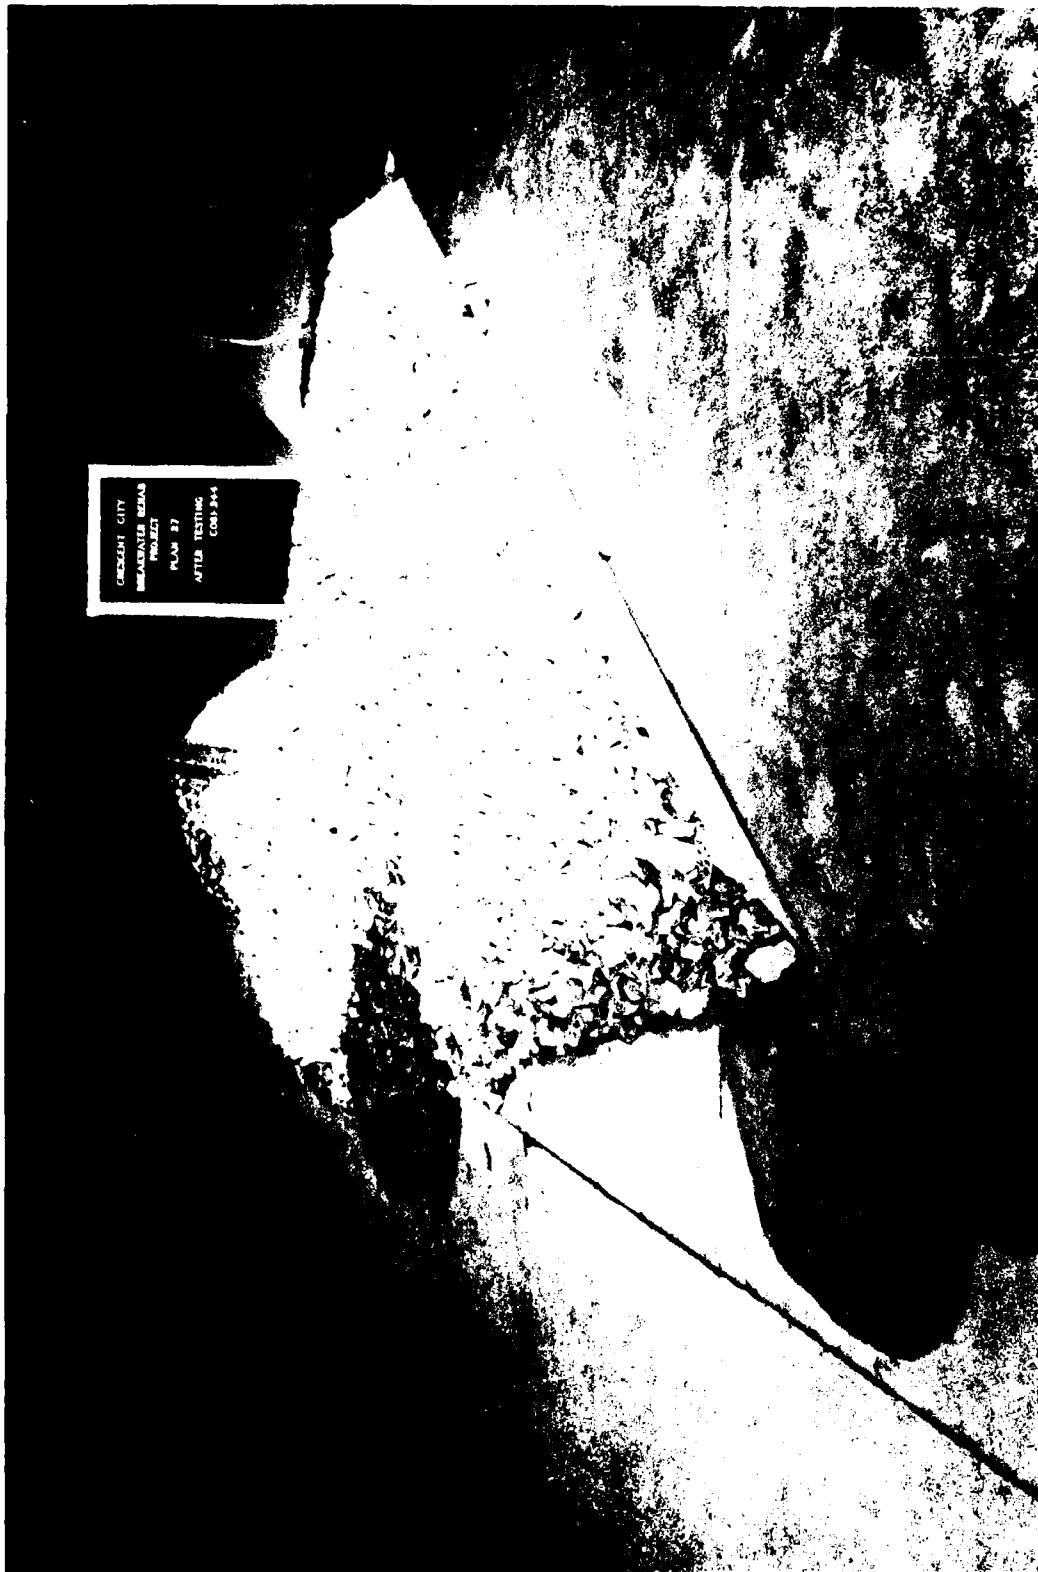
Photo 218. Seaward oblique view of Plan 27 after completion of abbreviated hydrograph

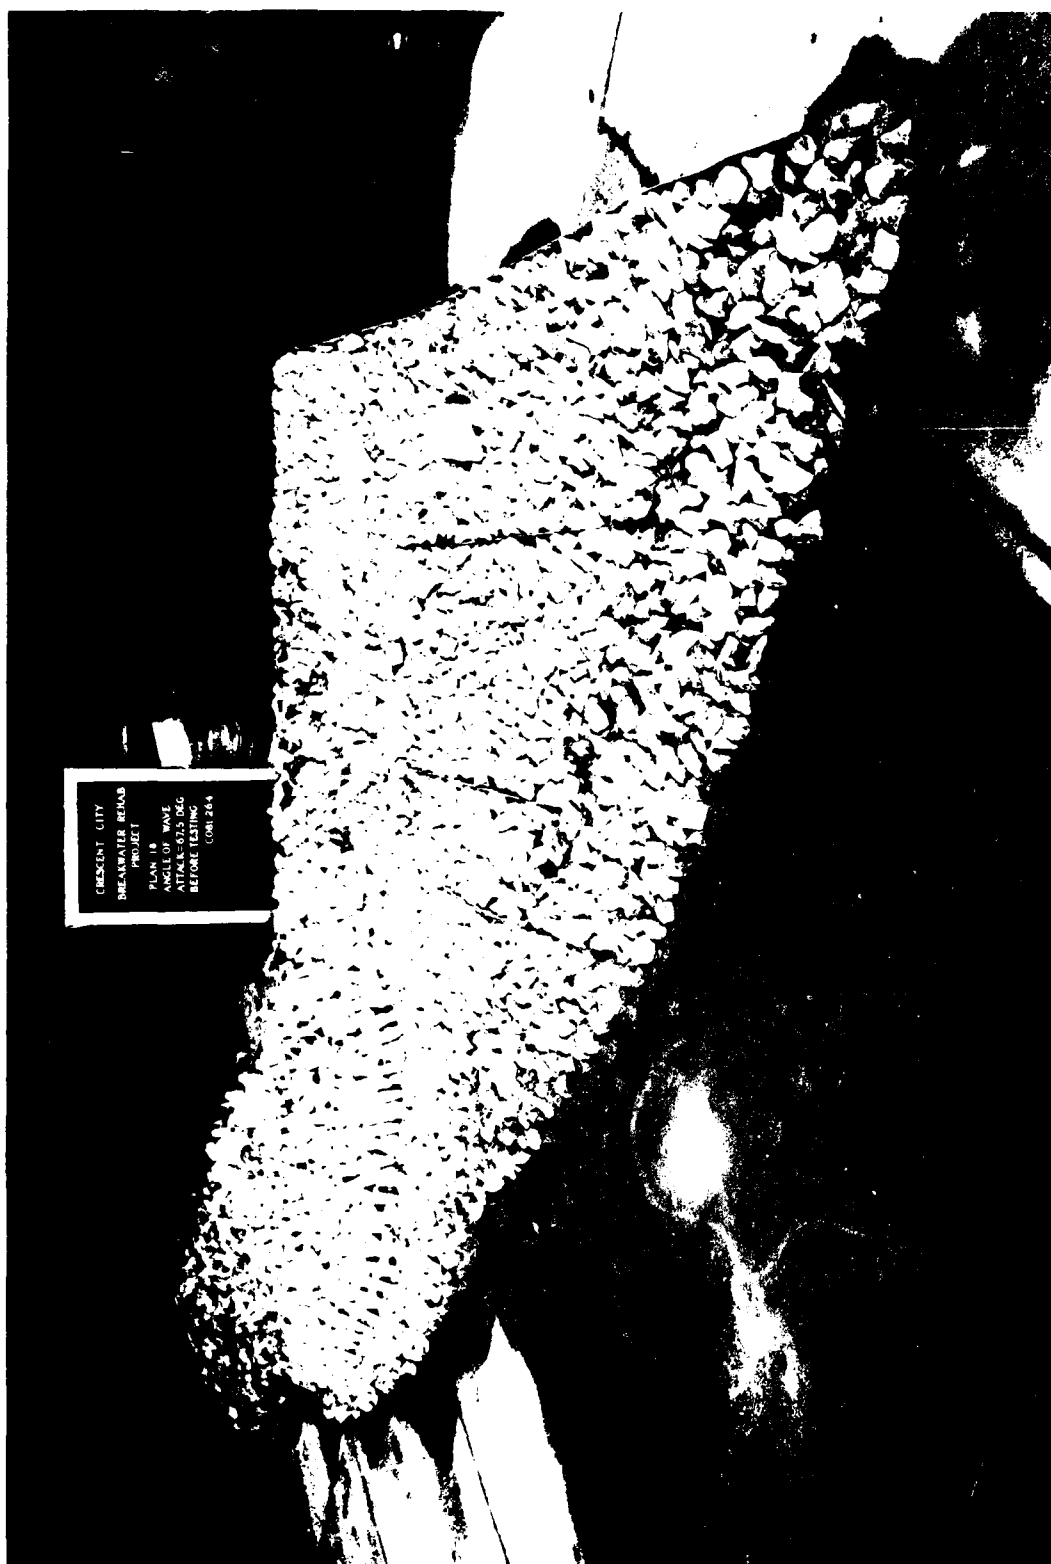
Photo 220. Sea-side view of Plan 18 before wave attack after modification to shoreward transition; 67.5-deg angle of wave attack

58. Plan 18 (Plate 30 and Photos 220-222) was constructed the same as for the 90-deg angle of wave attack except for a modification to the shoreward transition. Two rows of rehabilitation dolosse encompassed the existing units at the shoreward end. A total of 434 42-ton rehabilitation dolosse were placed. Subjection to Hydrograph A displaced three dolosse from the shoreward transition toe. The seaward transition suffered extensive damage during testing with 13 units being displaced. Photos 223-225 show the structure after testing with Hydrograph A. Plan 18 was rebuilt using 447 42-ton rehabilitation dolosse and subjected to Hydrograph B. The seaward transition again sustained extensive damage and the shoreward transition had moderate damage. Thus, Plan 18 proved to be unacceptable for the 67.5-deg angle of wave attack. Photos 226-228 show the structure after testing with Hydrograph B.

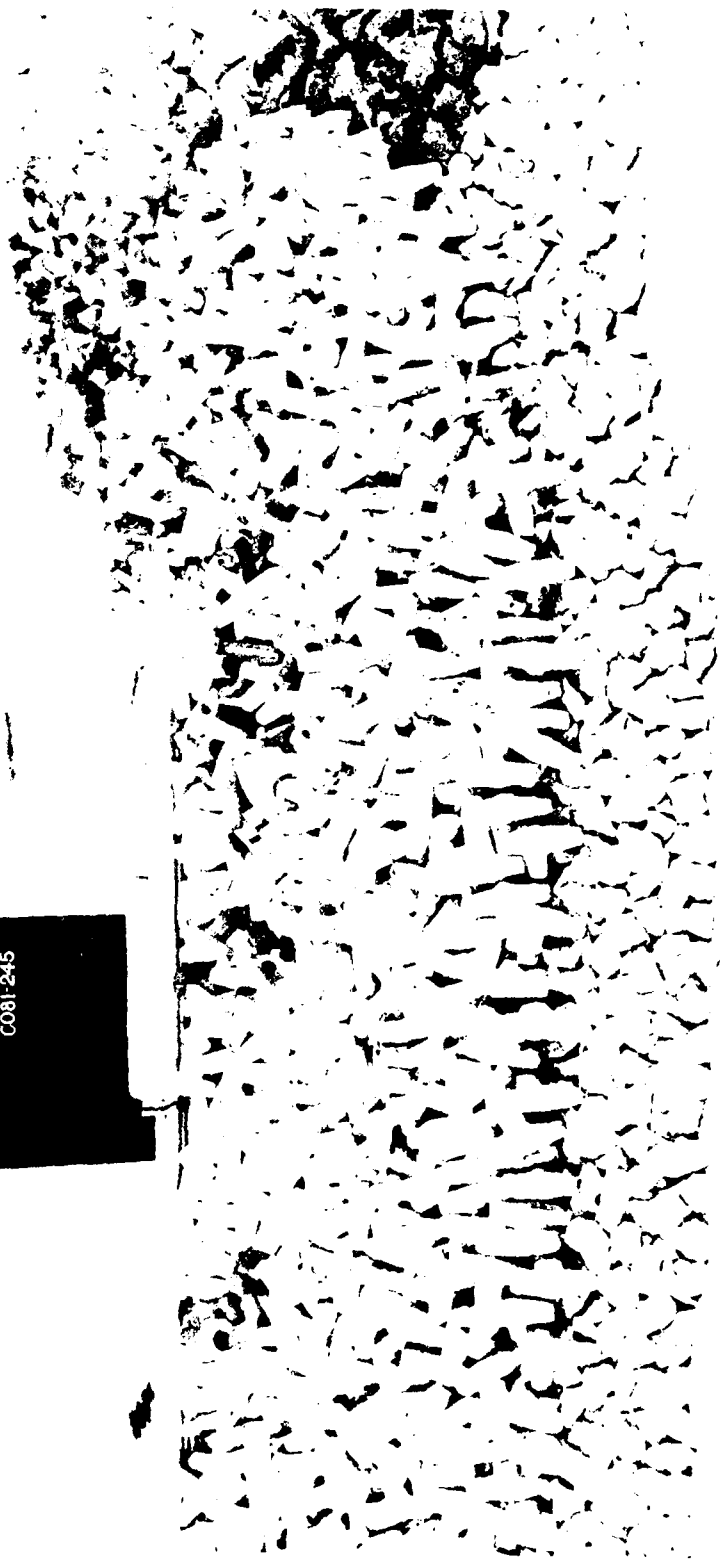
Photo 228. Seaward end view of Plan 18 after completion of Hydrograph B; 67.5-deg angle of wave attack

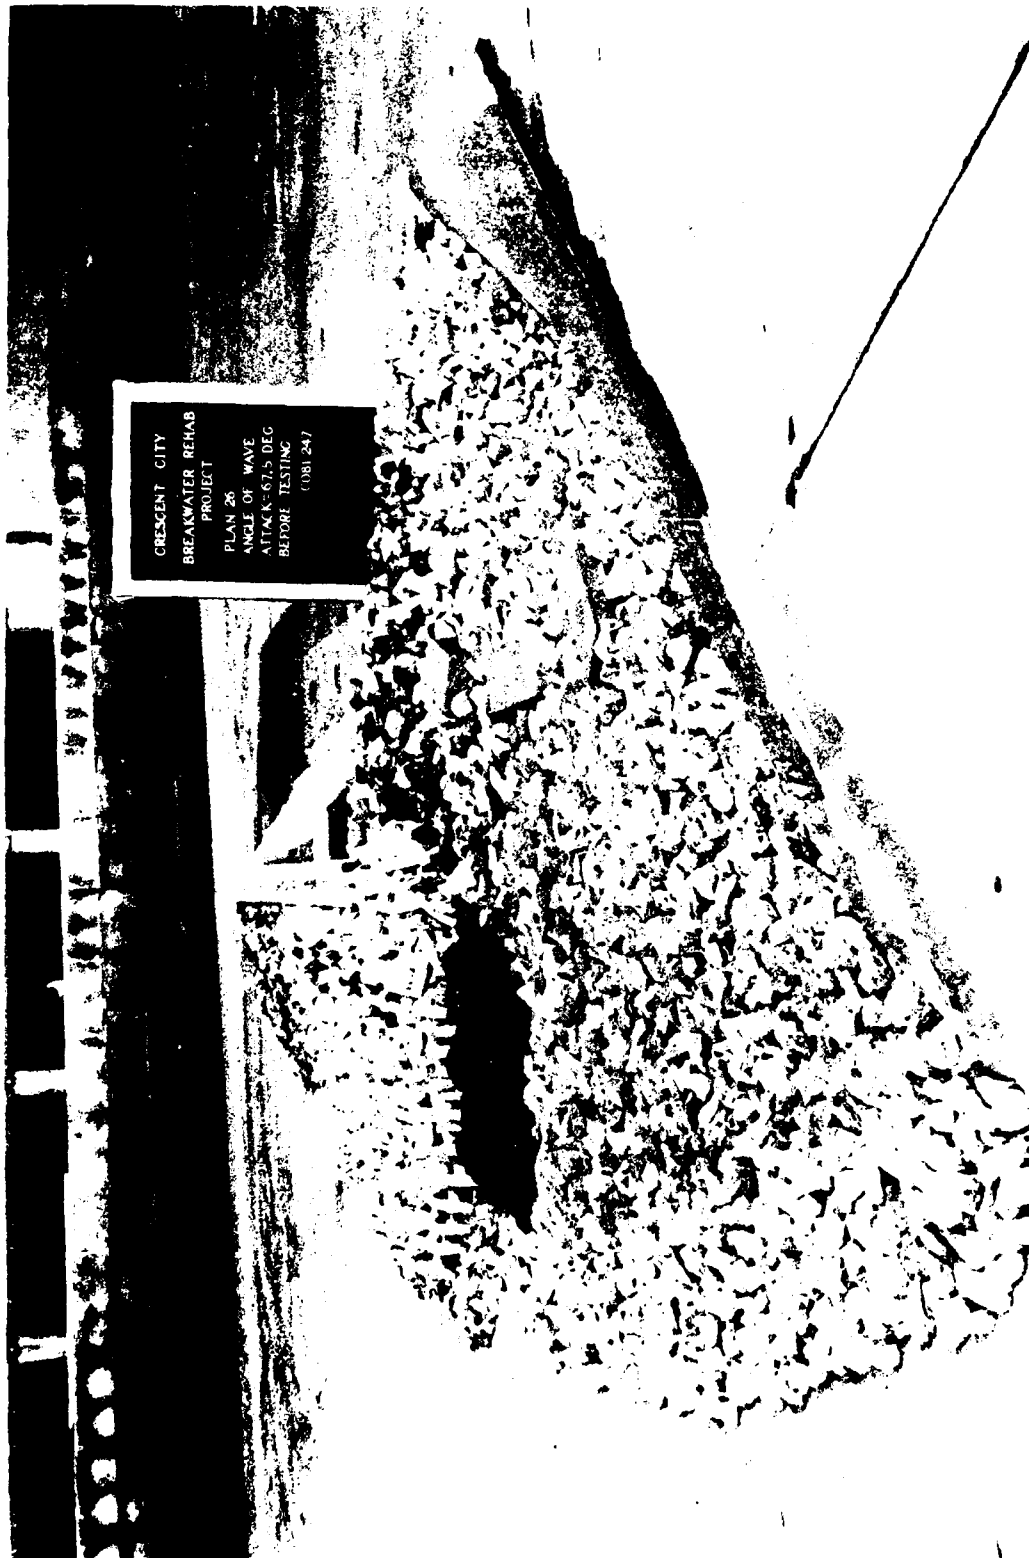
Photo 230. Seaward oblique view of Plan 26 before wave attack; 67.5-deg angle of wave attack

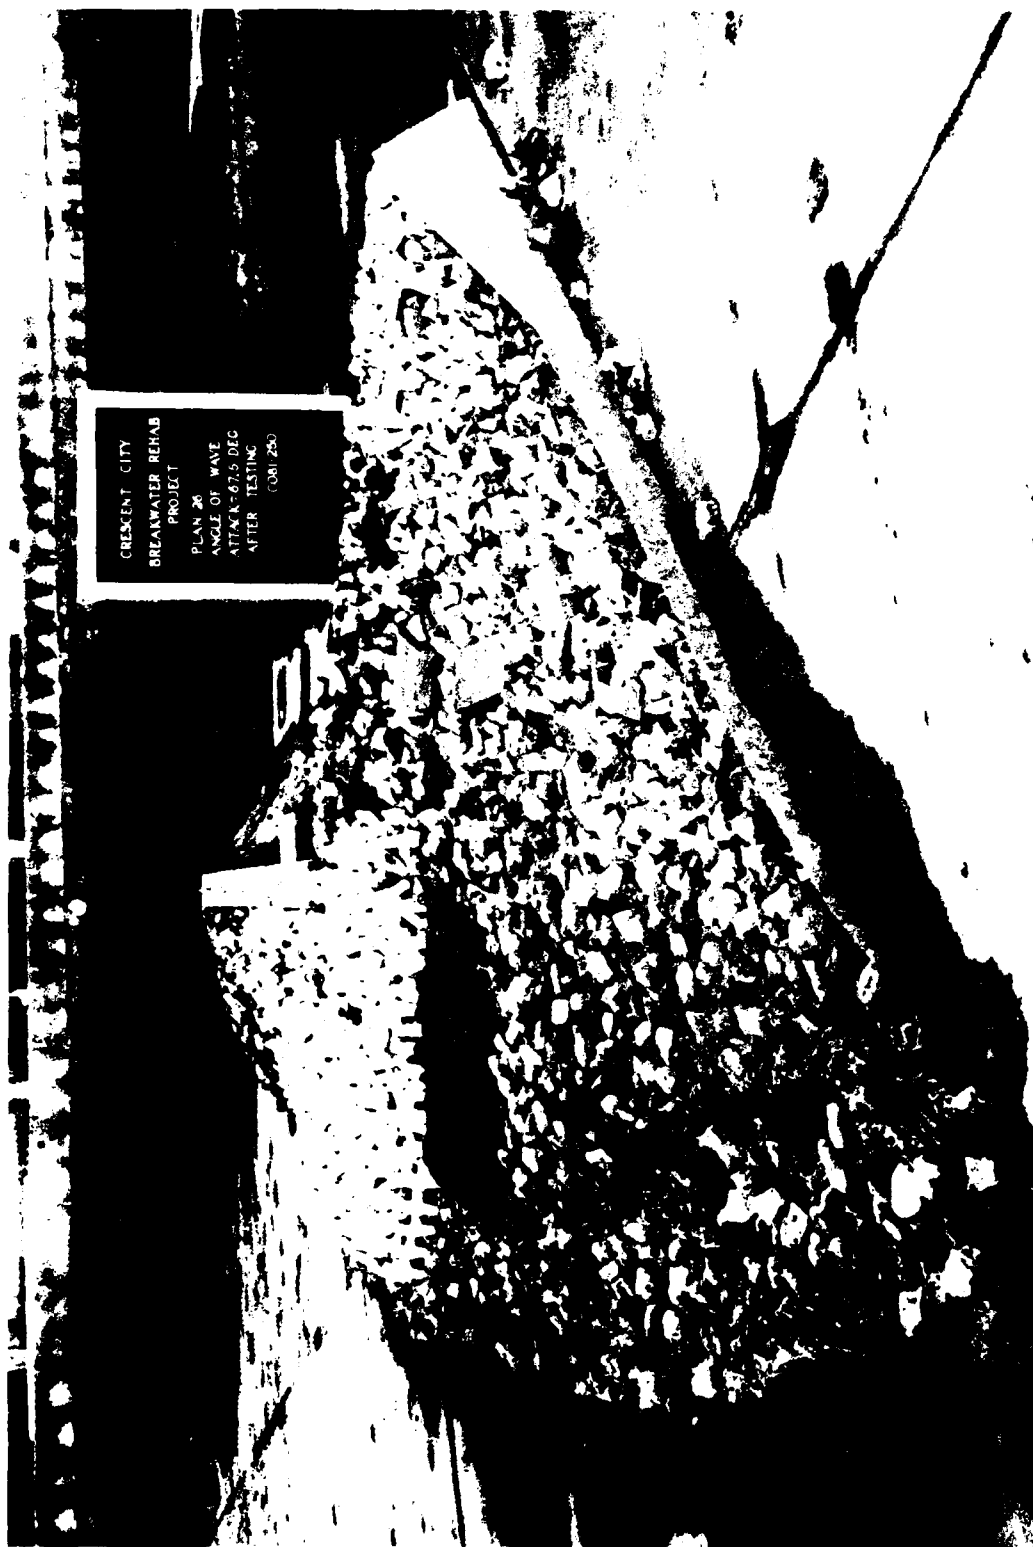
Photo 234. Seaward end view of Plan 26 after completion of abbreviated hydrograph; 67.5-deg angle of wave attack

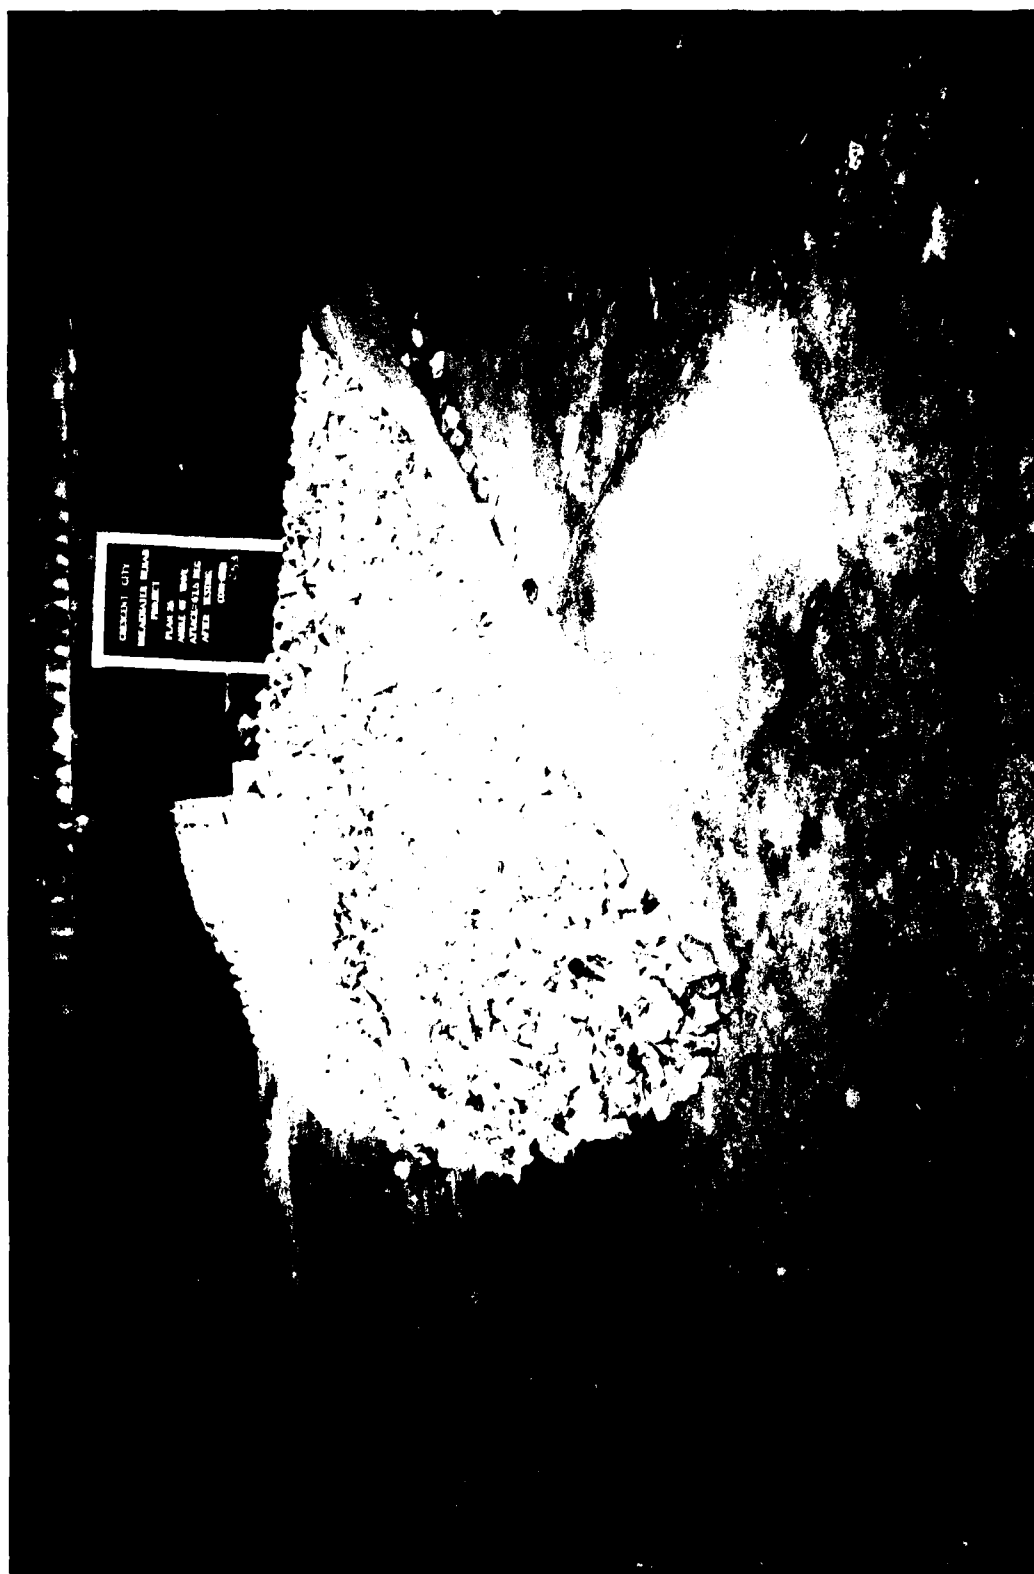
Photo 237. Seaward end view of Plan 26 repeat after completion of abbreviated hydrograph; 67.5-deg angle of wave attack

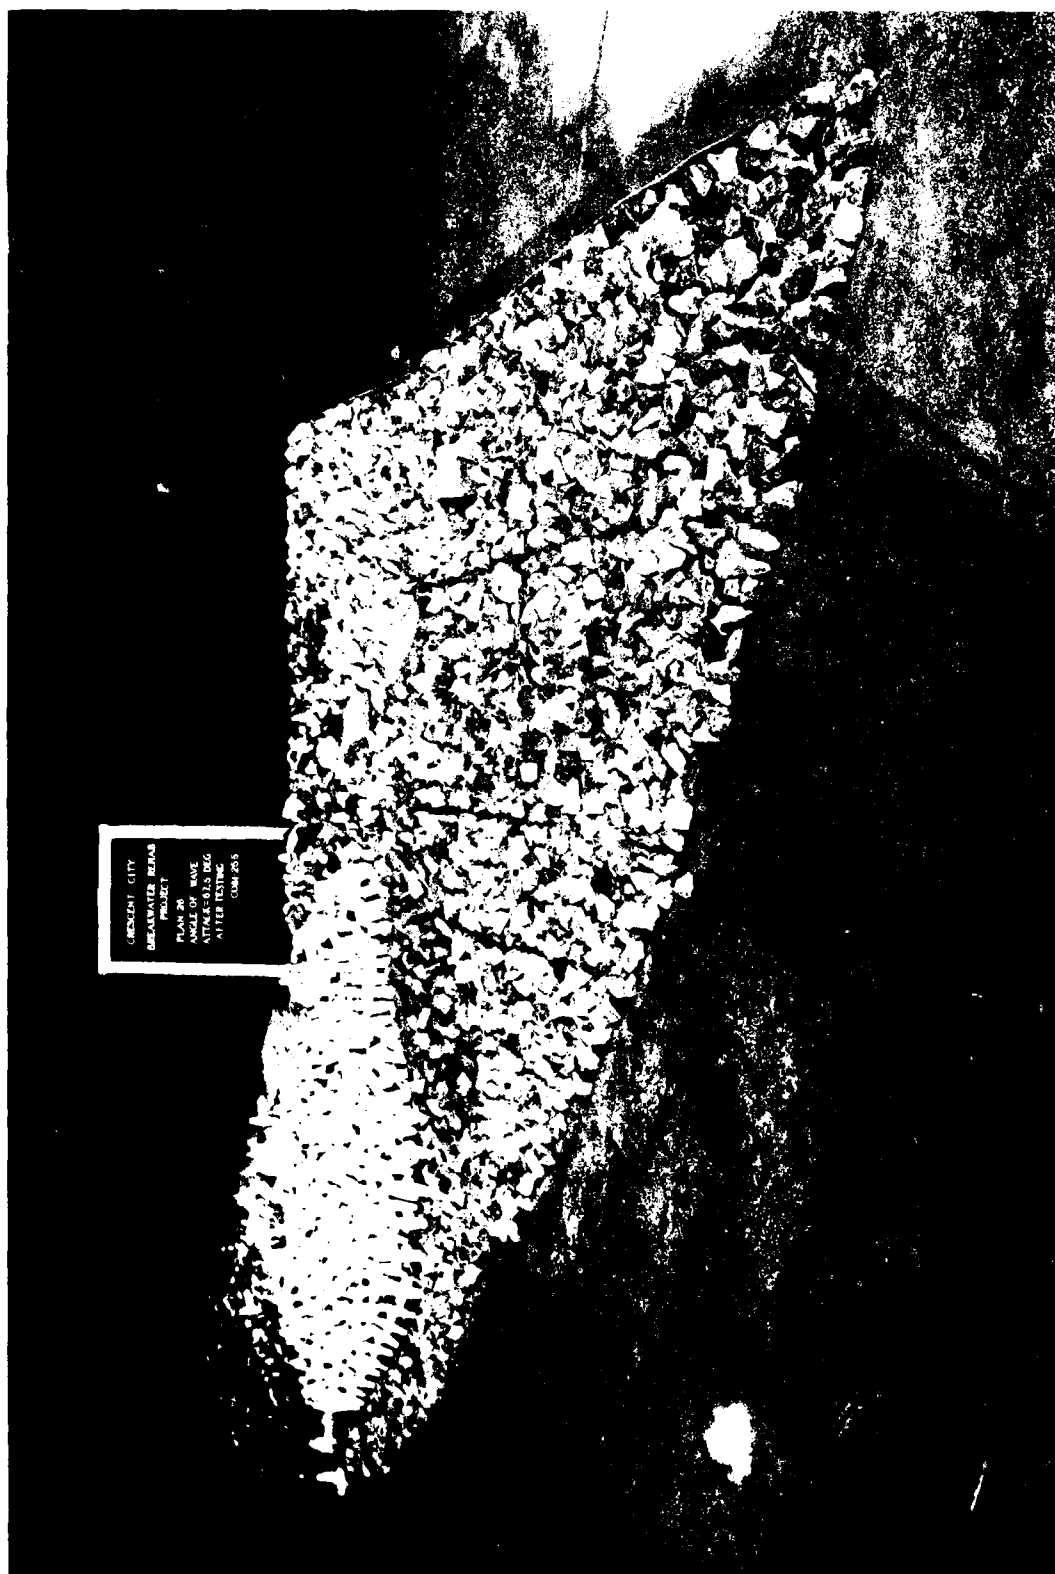
Photo 239. Seaward oblique view of Plan 26 after completion of Hydrograph A; 67.5-deg angle of wave attack

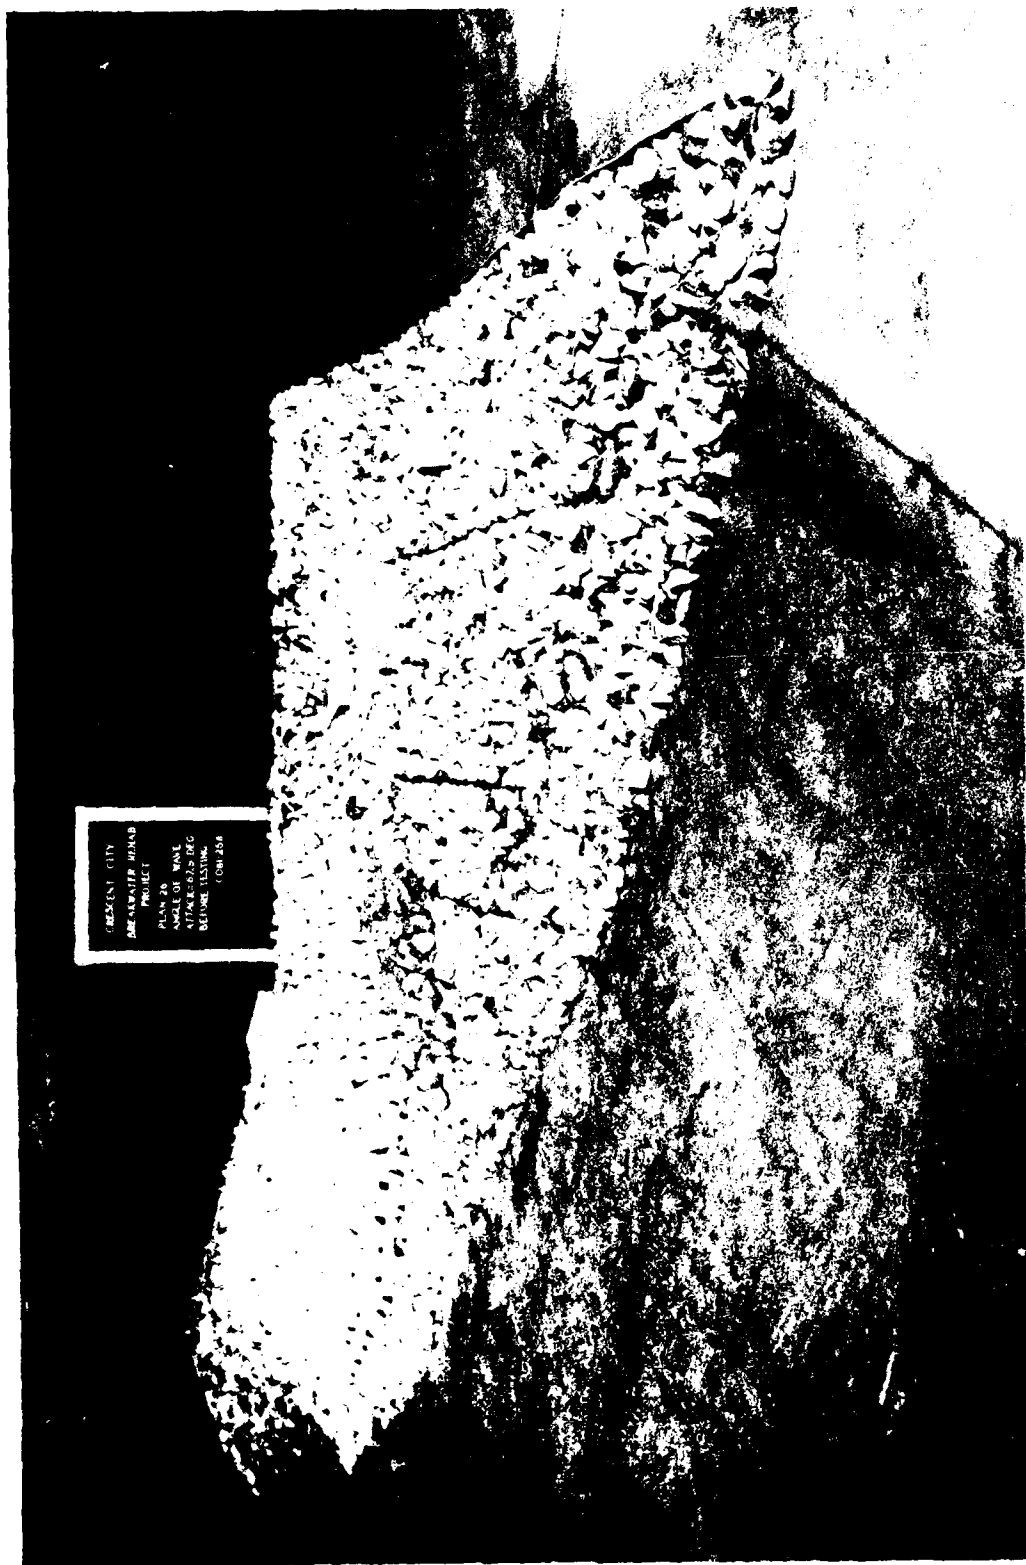
Photo 242. Seaward oblique view of Plan 26 before wave attack after modification to shoreward transition; 67.5-deg angle of wave attack

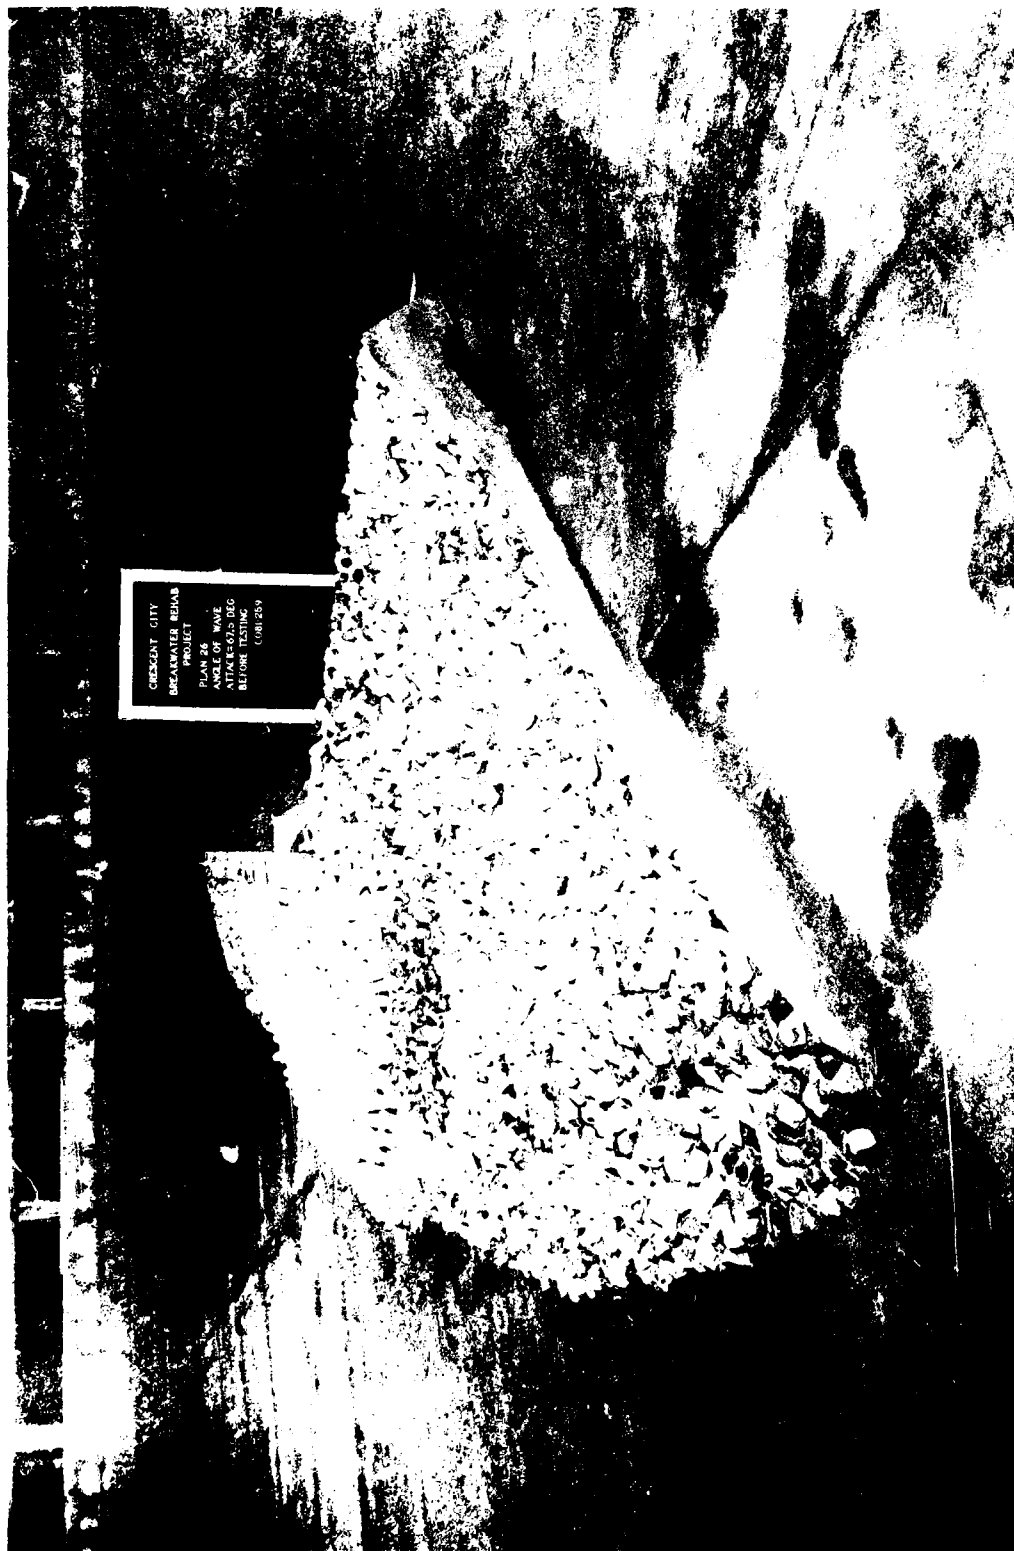
Photo 243. Seaward end view of Plan 26 before wave attack after modification to shoreward transition; 67.5-deg angle of wave attack

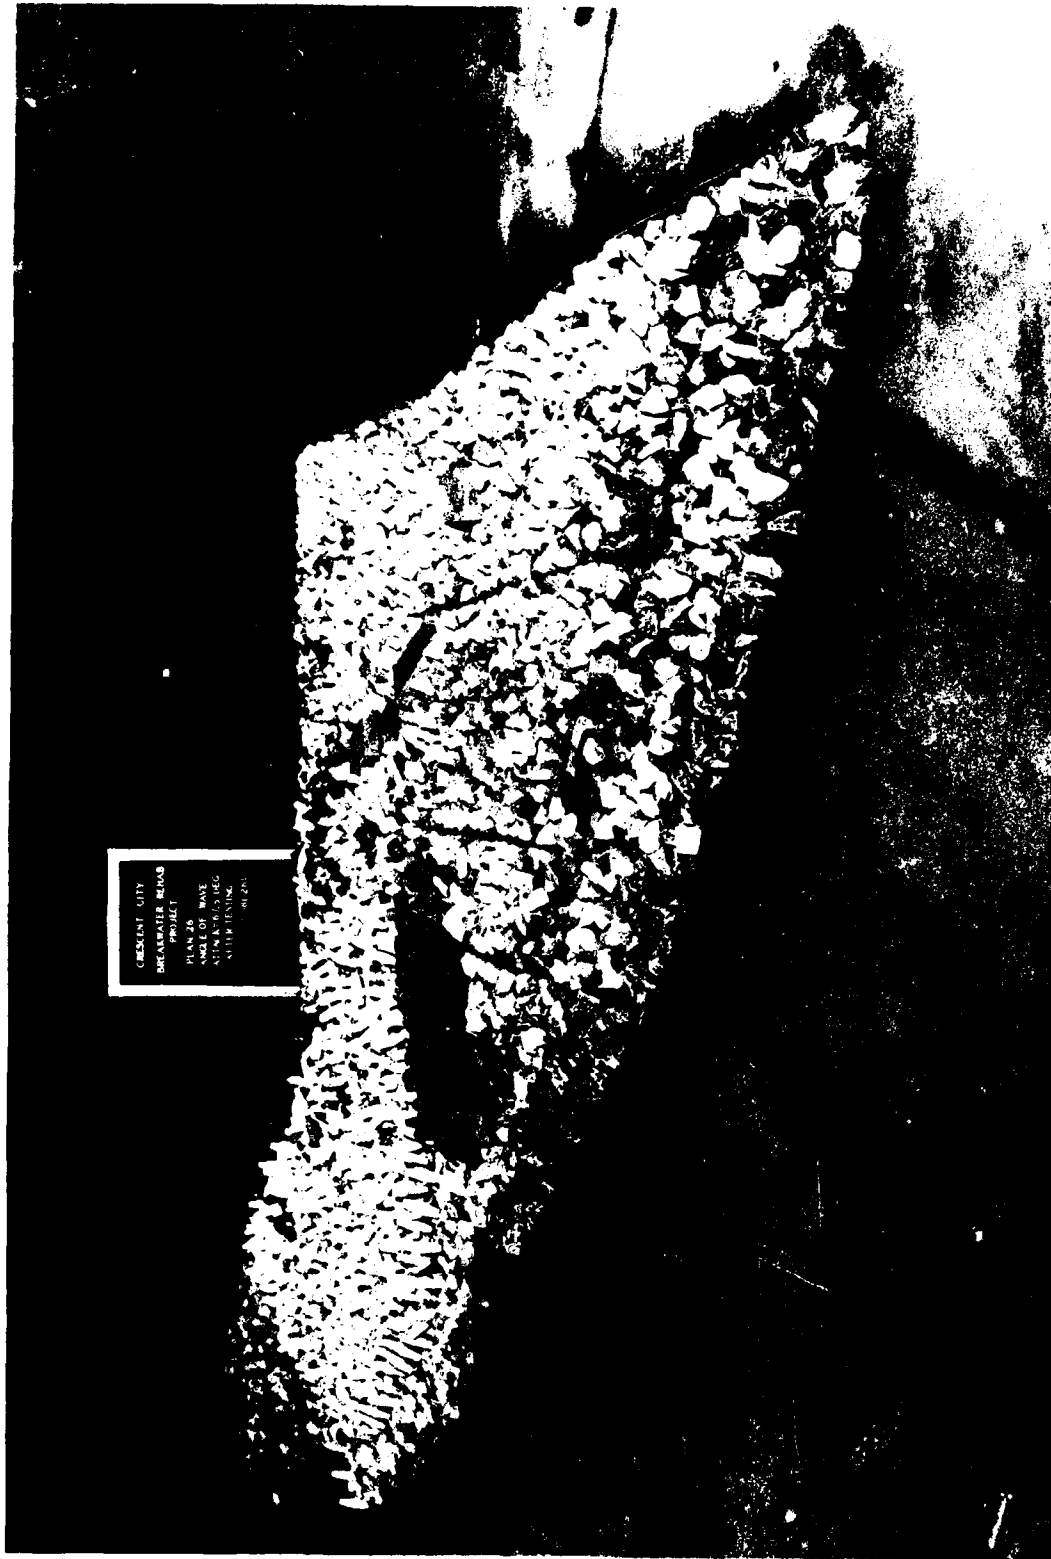
Photo 245. Seaward oblique view of Plan 26 after completion of Hydrograph B; 67.5-deg angle of wave attack

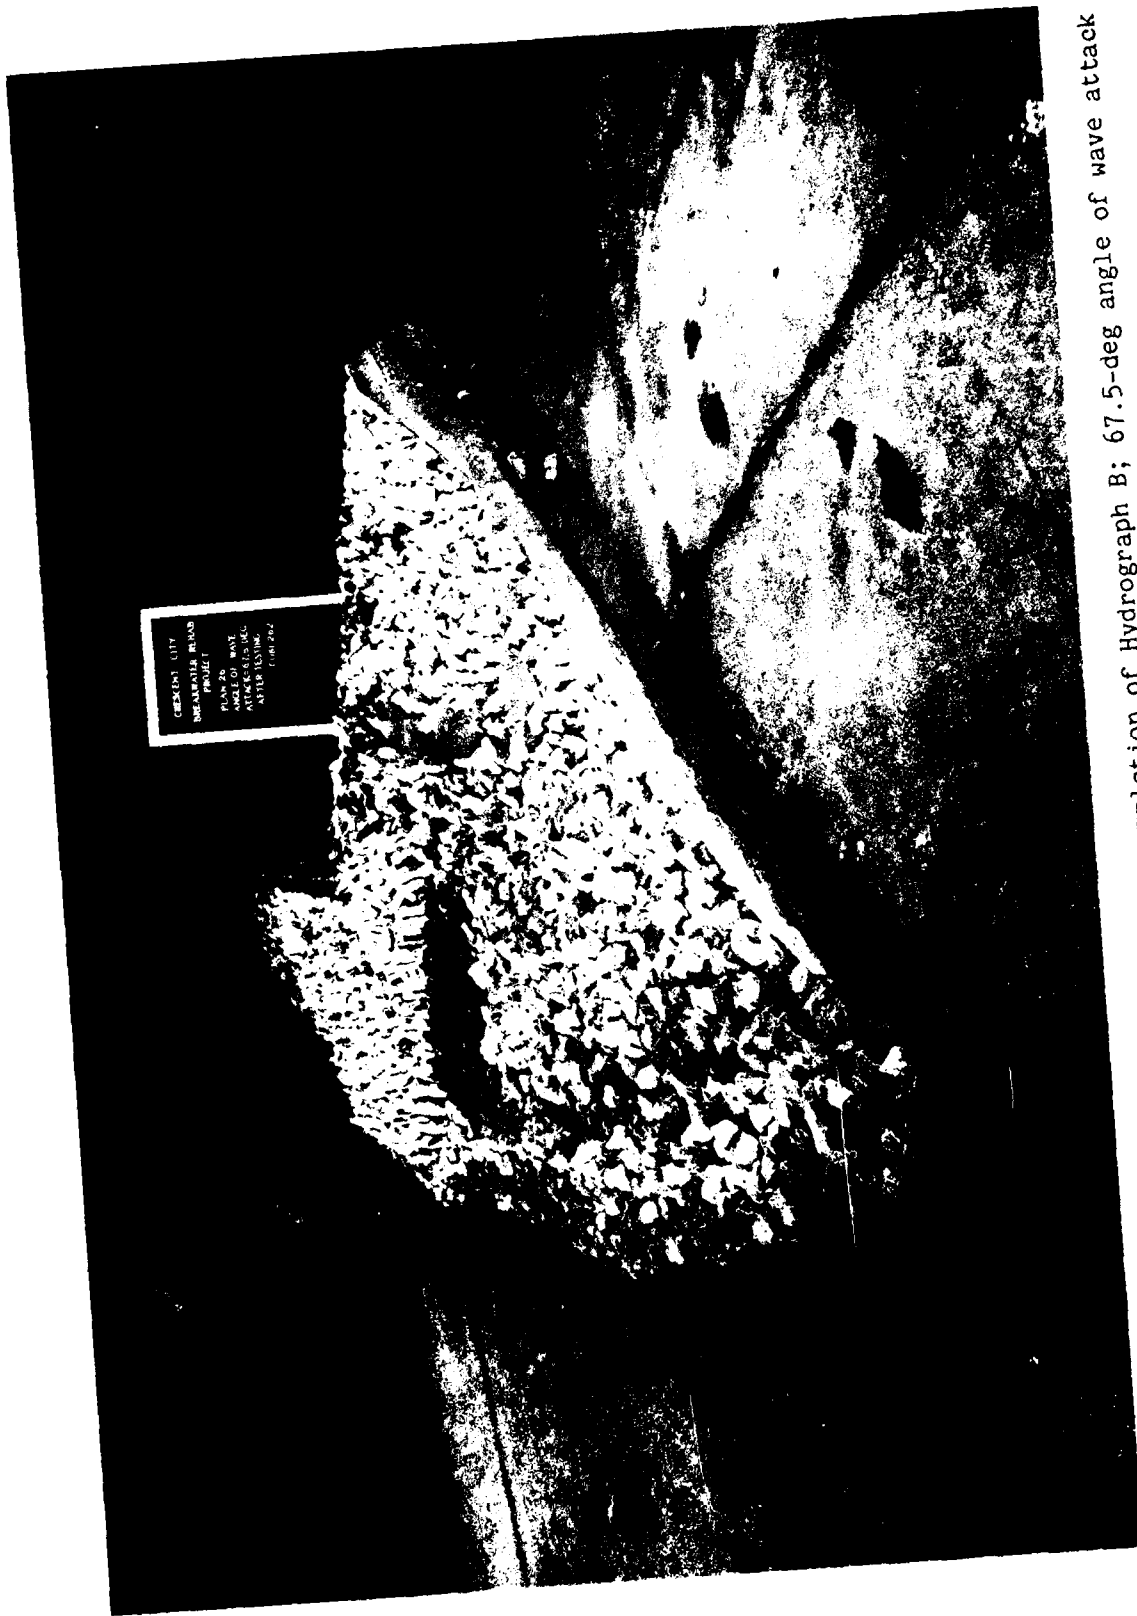
Photo 246. Seaward end view of Plan 26 after completion of Hydrograph B; 67.5-deg angle of wave attack
